Changes

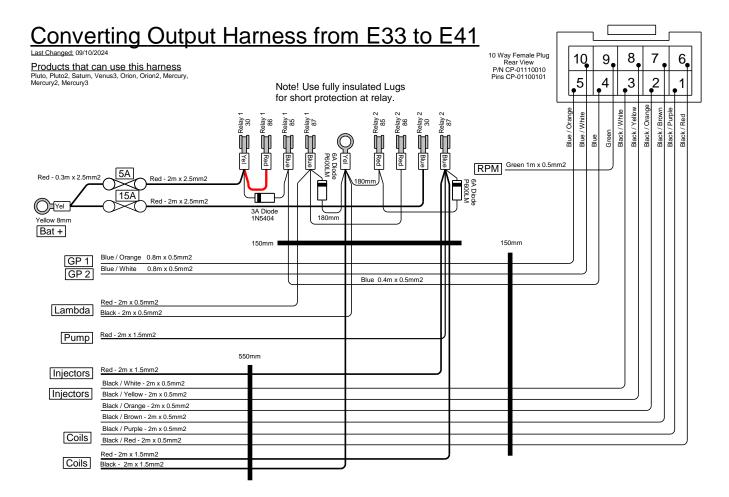
This modification ensures that the relay receives continuous power, even when the ignition is switched off. This allows the ECU to properly shut down the coils and injectors before the battery is disconnected, eliminating the negative voltage spike caused by inductive loads. This change is crucial, particularly if the clean power relay isn't implemented, to prevent damage—especially for the Venus3 ECU.

Orion2 and Mercury3 models have a clean power relay that provides power to the positive drivers. In these cases, when the ignition is turned off, the ECU can maintain the relay's power until the engine RPM reaches zero, then shut down. However, when the clean power relay is not required and isn't connected, parasitic power from capacitors can keep the relay on just long enough for a safe shutdown.

Note: On older models like Titan, Venus, and Venus2, this harness modification will prevent the ECU from shutting down properly.

On the E33, Relay 1 Pin 86 originally connects to the ignition key. This wire must now be changed to connect directly to Battery+. In the diagram, the red wire shows this connection. You can jump it to Pin 30, which is connected to battery positive. The rest of the wiring remains the same.
