Single Idle Valve

Last Changed: 24/08/2021

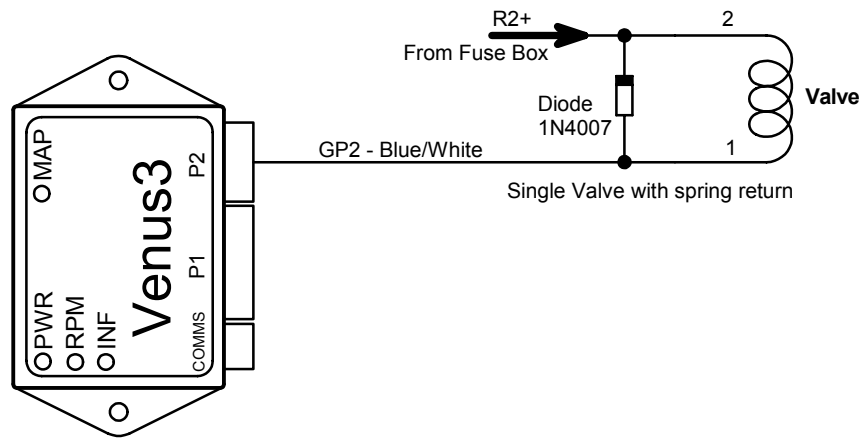
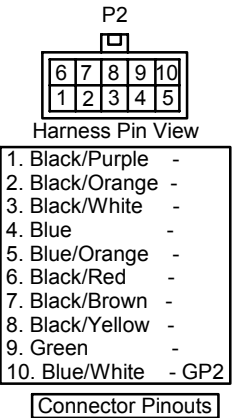
Warning!
Make sure that the Diode stipe is on the right side as damage will occur if connected wrong.
